Site 2. Former mine settling pond Rontok Wielki

Site description

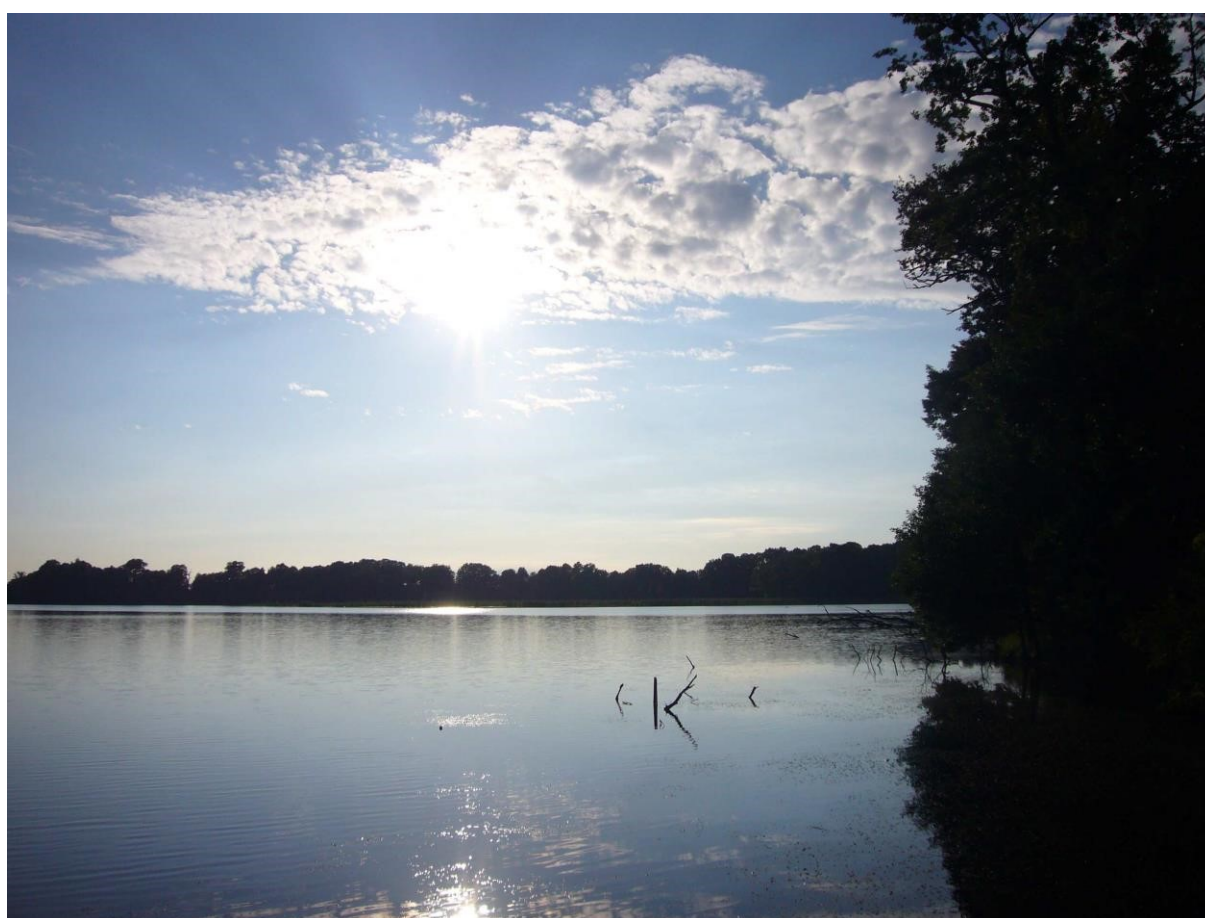
Fig 2. Rontok Wielki water reservoir (August 2014)

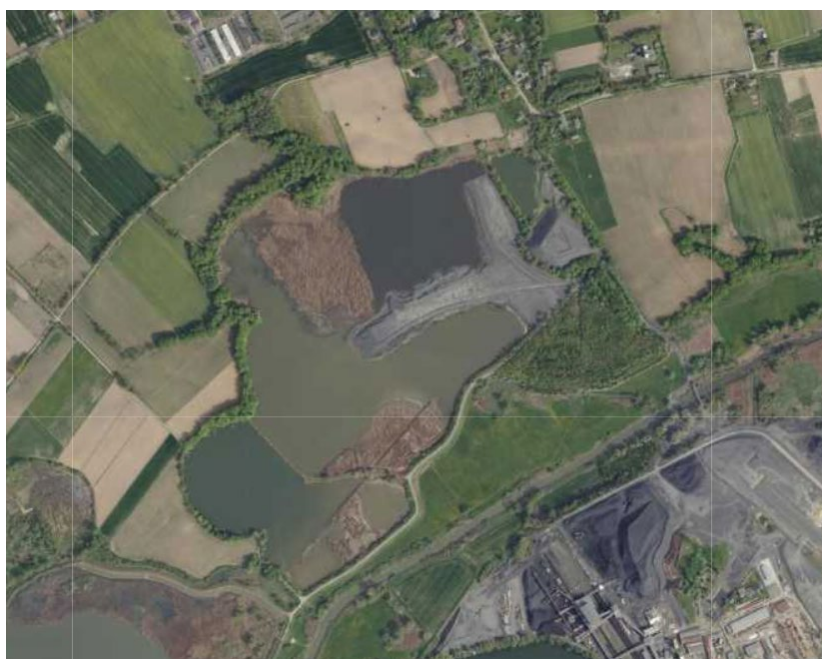
Due to economic situation and enforced limits in coal use rapid changes in coal mining industry in Poland are going on. Radioactivity is not considered to be important especially in the light of nor precise regulation in this field. In 2017 Rontok lake was sold to a private company and transferred into a repository of mine waste rock. A significant part of the lake is currently filled with waste rock and the process is going on.. see pictures below.

Fig. 2 Rontok lake partially filled with mine waste rock.

Use of the site as an observatory is irretrievable...on the other hand, thick layer of mine waste rock with content of natural radionuclides at the level not significantly exceeding natural background may be considered as a land reclamation, to some extent.
