Site no 4 - Bojszowy Reservoir

Bojszowy Reservoir - Radium-bearing waters.

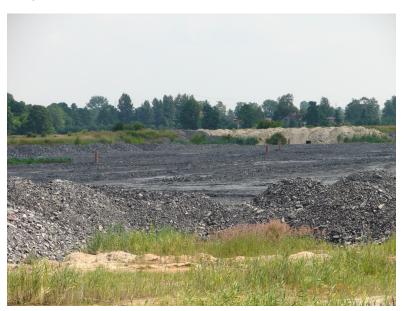
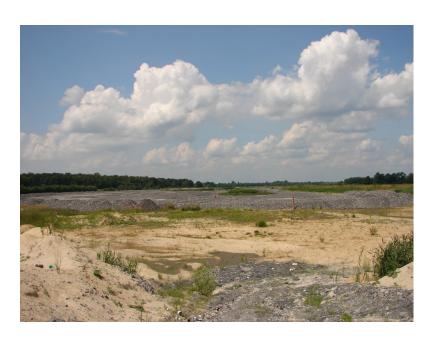
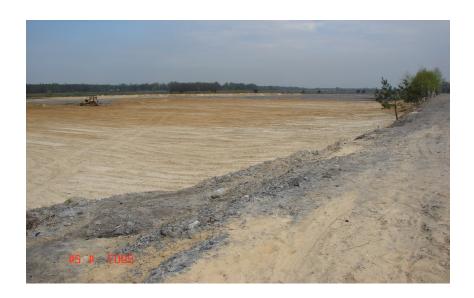
In 2010 at the area of the Bojszowy settling pond the process of land reclamation was finished. Sediments have been left at the original place and covered by the layer of the inert material. The first, the waste rock from coal mine was used and the layer about 1 m thick was created. After that the thin layer of sand was put on the top. Finally the top level of settling pond area is still below the banks but 2-3 m above the level of neighbouring land and representing typical wasteland landscape. See pictures below.
